# Landfill leachate treatment

## Planted soil filter Hamburg-Havighorst

### **Planted soil filter Hamburg-Havighorst**

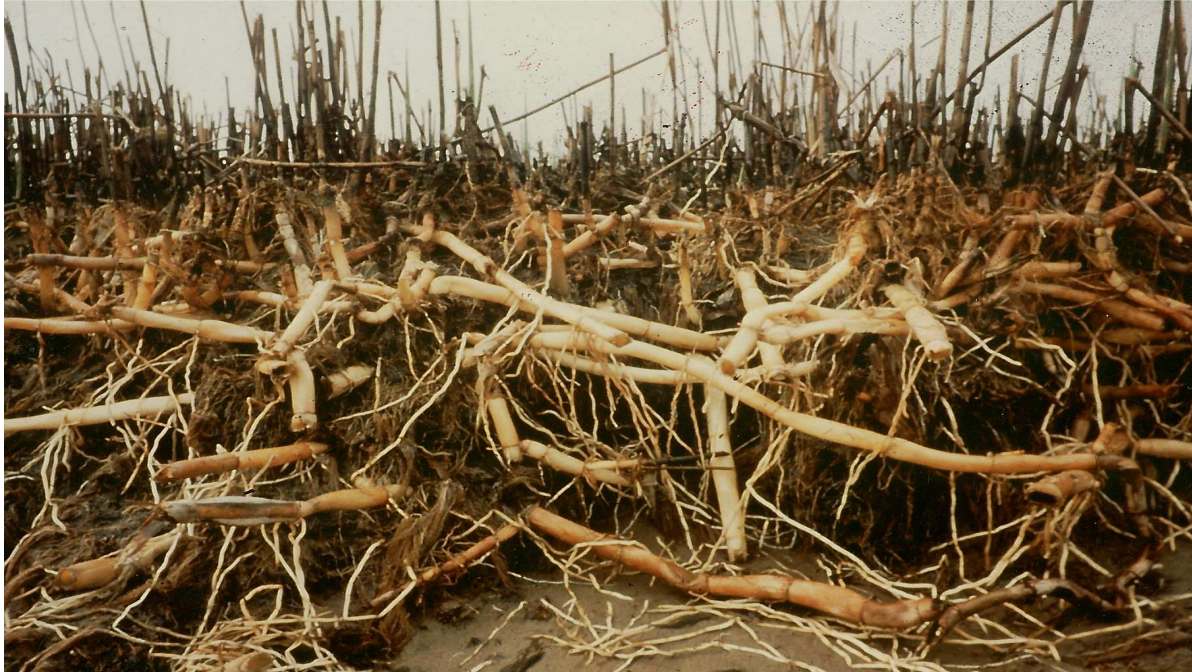
root and rhizome meshwork of reed (*Phragmites communis*)
